Twp 142 Rge 27 Index No. A.0-04.0

CERTIFICATE OF LOCATION OF GOVERNMENT CORNER

East Sixteenth corner of Section 6, Township 142 N., Range 27 W., 5th P.M.
State of Minnesota, County of Cass

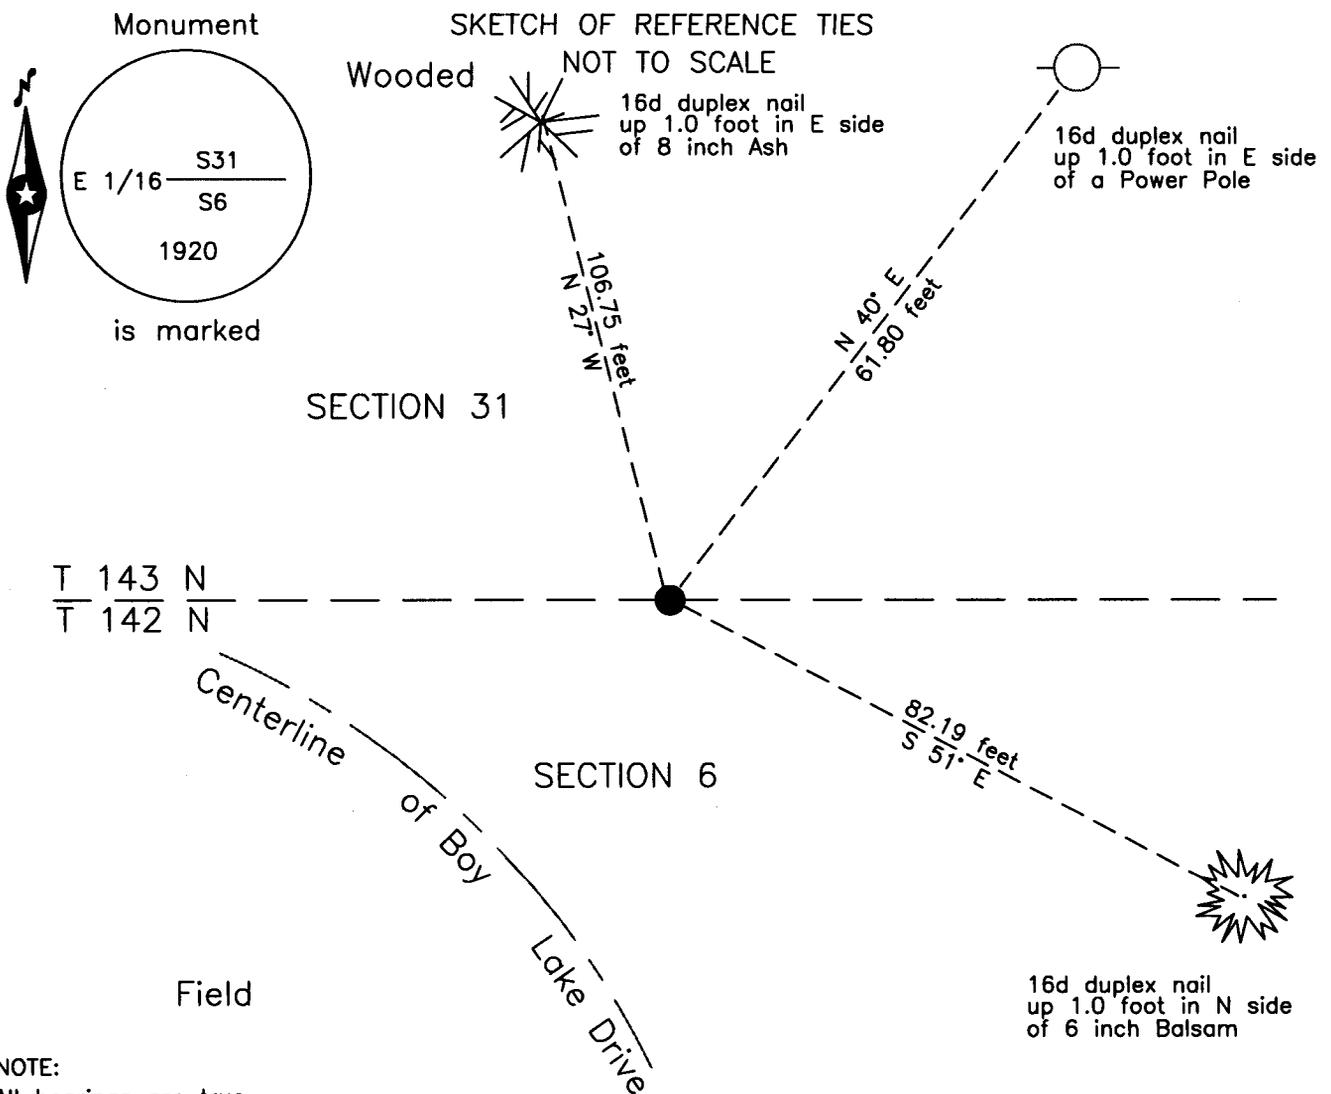
At the corner location shown on the sketch:

On 19 June 2009 found a 1 inch outside diameter iron pipe with GLO brass cap,
top bent.

On 19 June 2009 placed a straightened GLO monument at recovered location.
