CERTIFICATE OF LOCATION OF GOVERNMENT CORNER

Northeast Corner of Section 36, Township 135 N, Range 30 W, 5th P.M.

Northeast Corner Section 36, Township 135 North, Range 30 West

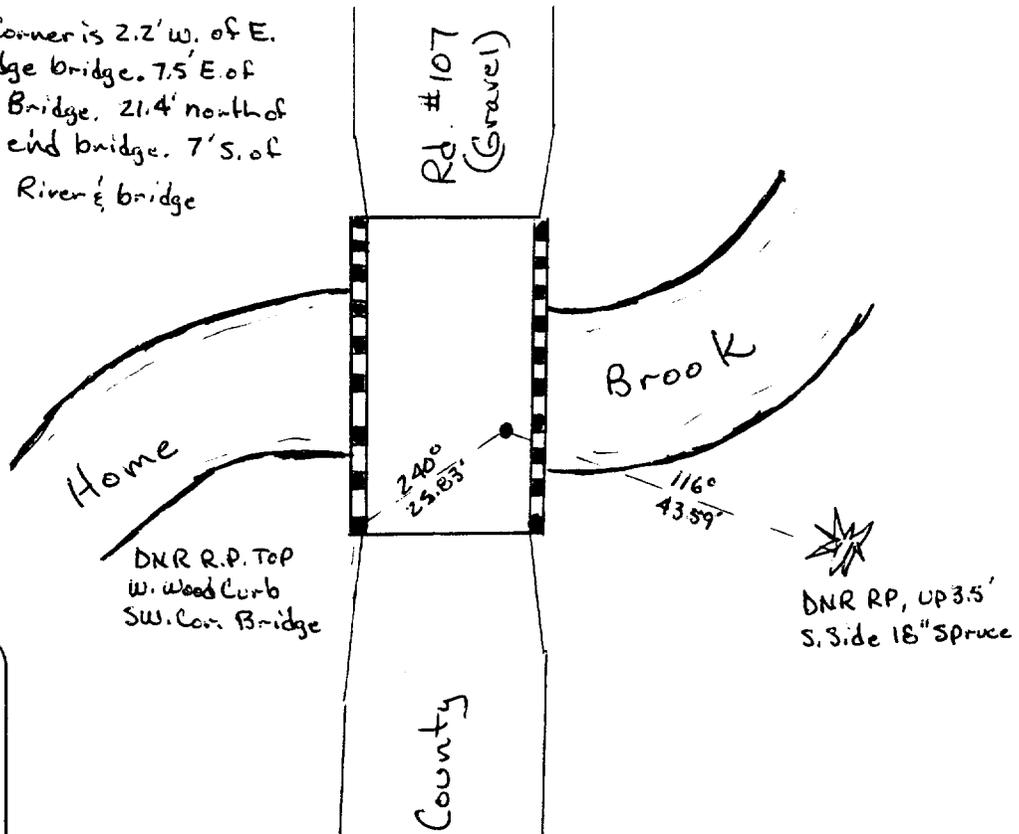
SKETCH OF REFERENCE TIES

Note: Corner is 2.2' w. of E. edge bridge. 7.5' E. of E. Bridge. 21.4' north of S. end bridge. 7' S. of E. River & bridge

NAD 1983
Cass County
Coordinates
N 214,842.12
E. 518,762.85

Azimuths taken with Compass

- On _____ found a _____
- DATE
- left monument as found, lowered monument, removed monument (explain)
- On 6-30-97 Placed a PK and DNR Disc in deck of wooden bridge
- DATE

1997 The DNR survey crew searched for evidence of this corner. There is a bridge over Home Brook in the area of the corner. Occupation was located along the section lines north and south of this corner. No conclusion could be reached from the occupation lines. The crew talked to Mr. Holsapple, about 80 years old, who has lived in the area all of his life. He remembers seeing a CCC post at this corner and later seeing an iron pipe at the corner. He said it was taken out when the new bridge went in. He said the iron was at the south end of the bridge and on the south side of the river. He said the fences in section 36 don't mean much and they were just put in where the landowners thought they should go. The new bridge was built above where the old bridge was. Parts of the concrete for the old bridge is still in place under the new one, but it is difficult to tell where the south edge of the old bridge was. The corner was reviewed with Landecker and Associates and Terry Freeman, the county surveyor. There are no old road records to state where the road is in relationship to the corner and the corner has been accepted as lost in previous surveys therefor the corner was accepted as lost. A PK nail was set in the bridge to mark the corner.
