T. 142 R. 28 M. 5th Coordinates: X _____ Y _____
NE 1/4 1 Corner common to sections 1 and 36-143-28

CASS COUNTY LAND CORNER RECORD

T. 142 R. 28 M. 5TH Coordinates: X _____ Y _____
N 1/4 Corner common to sections 1 AND 36-143-28

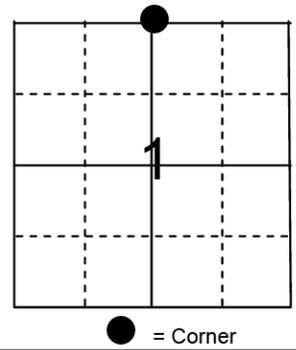
7/1993, C. Krause and R. Main, technicians, USFS
USFS, Book 1, page 2 T143N R28W
 No evidence of GLO or County irons. From 1/4 S36
 evidence of both GLO Elm's set a 2" x 24" iron S1
 pipe with brass cap 10" below road, 2.0' S. of T142N
 centerline Co. Rd. #172" and witnessed. 1993
6" W. Oak, N 26° W, 104.75' USFS
8" W. Oak, S 03° W, 39.99'
10" W. Oak, S 31° W, 55.46'
Steel Sign Post, South, 30.75'

Year of search 8/2009 By CCHD/SO
 Location filed: #2009.025
 Monument: Found USFS brass capped iron pipe
 down 1.0', 3'+, -, S. of centerline of Co. Rd. #172, the 1993
 USFS witnesses all good.

8/2019, CCHD/SO
#2009.025
 Found mag nail, 3'+, -, S. of centerline Co. Rd. #172, USFS
 1993 witnesses all good.

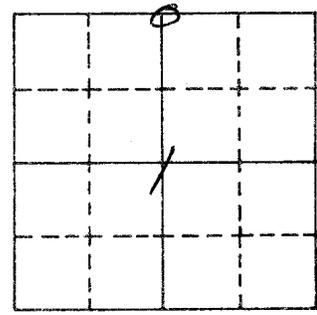
O = Corner

1920 GLO Elm S22°E, 43.56' (Snag)
5" W. Oak N26°W, 104.75' 60d spk
8" W. Oak S31°W, 55.46' 60d spk
8" W. Oak S3°W, 39.99' 60d spk.
Sign Post South, (survey man sign)

3/2001 CCSO crew found Brass cap,
down 0.4', 3'± S. of & CR# 172.
1993 witnesses good.
